THIRD FLOOR PICTURES

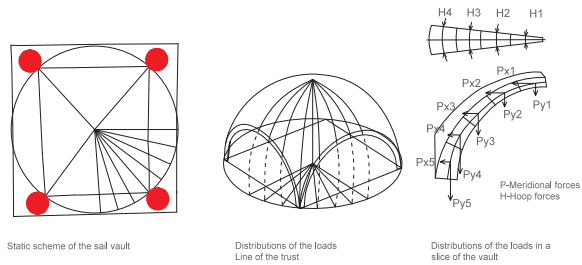
STATIC SCHEME OF THE SAIL VAULT

The main stress concentration was in the corners of the third floor of the tower. Some of the existing cracks on the last floor of the tower could be result of this vault presence. We could look at the series of passing through cracks in the corners of the walls. Another one, such as significant vertical crack in the middle of the wall could be the result of the vault dismantlement or the progressive process of the tower declination.

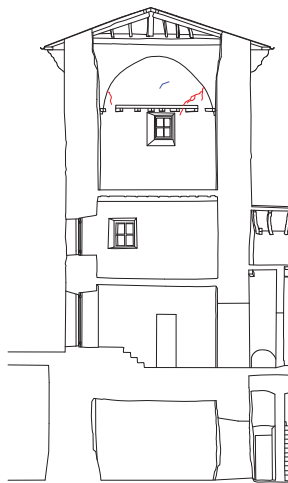
GROUND FLOOR

On this wall we could see two deep cracks in the corners on which the vault was endorsed. The one on the right is particularly deep and is passing through the wall. These could be accentuated due to the progressive out of plumb of the tower.

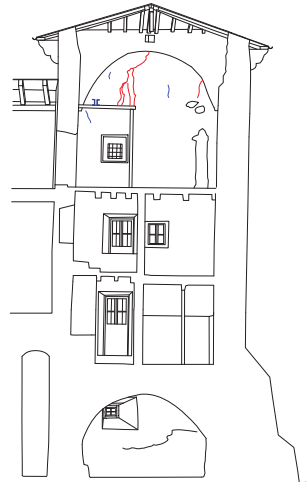
GROUND FLOOR

This wall presents a series of non passing and passing cracks that follow the same direction and the typical cracks on which the sail vault was endorsed. One of this crack is really deep and with a complex morphology made of divided cracks that start from big one. Also in this case the direction is due to the progressive displacement and rotation of the tower. Also in this floor the intervention to put two C shape beam and wooden beams could have damaged the structure and increased cracks on the wall.

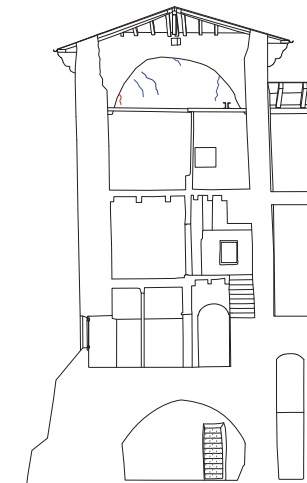
GROUND FLOOR

This wall presents a series of non passing cracks that follow the same direction and the typical cracks on which the sail vault was endorsed. This direction is due to the progressive displacement and rotation of the tower. On this floor two C shape beam and wooden beams were also put to create a new space.

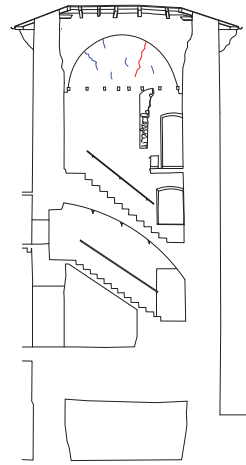
GROUND FLOOR

This wall presents a series of non passing cracks, differentiated by dimensions and shape, with one big passing crack. This one is due to the action of dismantlement of the sail vault. Also in this case the direction is due to the progressive displacement and rotation of the tower. Also the interaction among adjacent building could have created cracks on this wall of the tower.

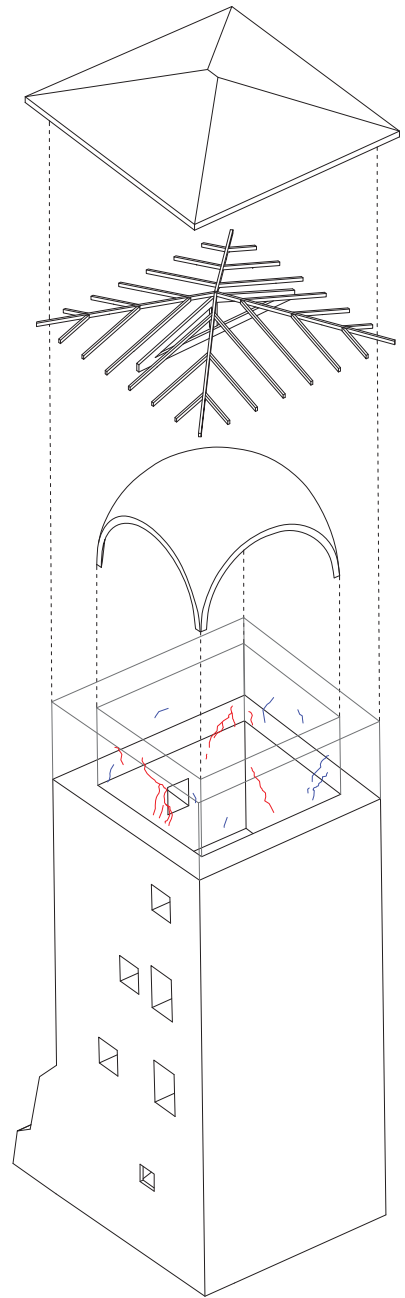
FIRST FLOOR AXONOMETRIC VIEW OF CRACK PATTERN

On the masonry we could analyze many cracks of different typologies and dimensions. Most of the cracks in this floor are directly related to the problems of the load of the vault on bearing walls. Cracks are mainly concentrated in the corners, on which the vault was supported.
