THIRD FLOOR PICTURES

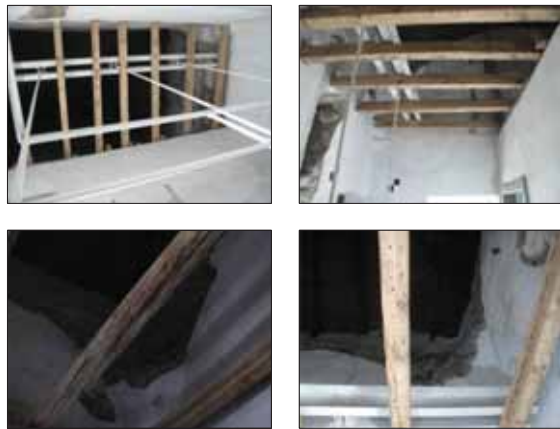
The main stress concentration was in the corners of the third floor of the tower. Some of the existing cracks on the last floor of the tower could be result of this vault presence. We could look at the series of passing through cracks in the corners of the walls. Another one, such as significant vertical crack in the middle of the wall could be the result of the vault dismantlement or the progressive process of the tower declination.
